# Inspection Report

Property Address:

Portland OR

### Executive Summary

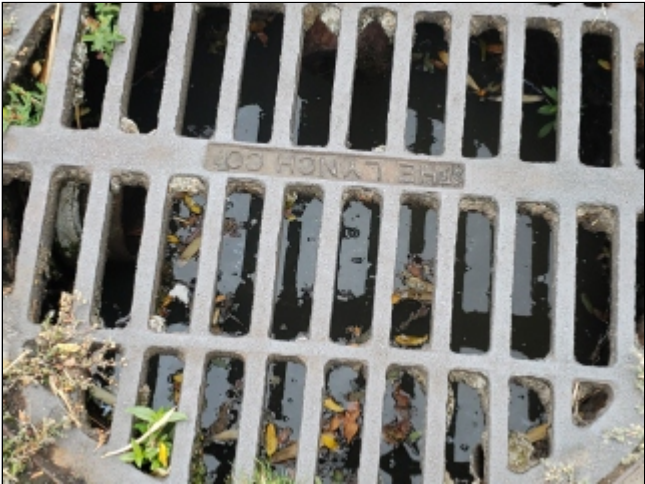
- B. Item 1(Picture)  
Drainage swale is filled with silt and debris, past due for cleaning service.
- C. Access and Egress  
IN
- D. Paving, Curbing and Parking  
RR

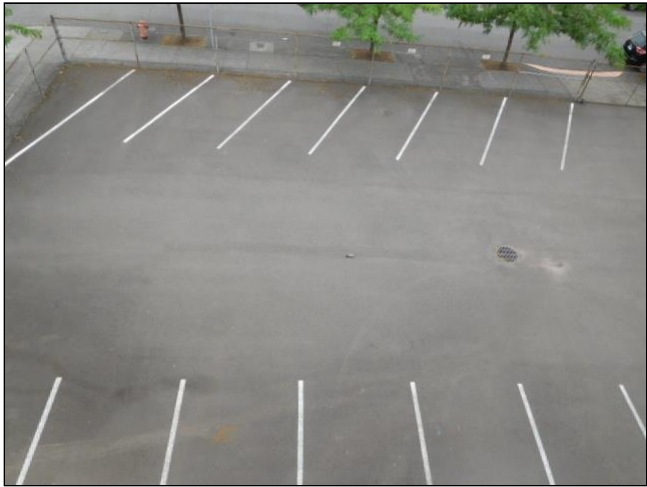
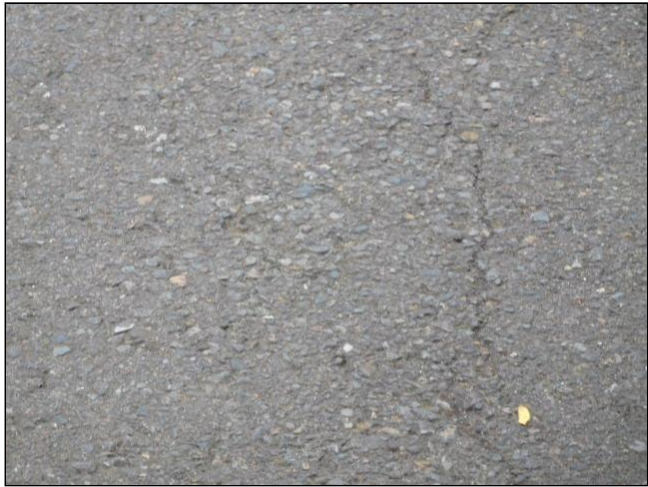
The asphalt parking due for seal service. We recommend asphalt surfaces be seal serviced about every five years in this climate. Neglect will result in " alligator cracking and deterioration. Ultimately the surface will need to be resurfaced with a 2" overlay of new asphalt. The difference in cost is about \$0.18/SF for seal service and \$2.00 SF for an overlay.

There is about 6,500SF of asphalt.

The asphalt parking due for seal service. We recommend asphalt surfaces be seal serviced about every five years in this climate. Neglect will result in " alligator cracking and deterioration. Ultimately the surface will need to be resurfaced with a 2" overlay of new asphalt. The difference in cost is about \$0.18/SF for seal service and \$2.00 SF for an overlay.

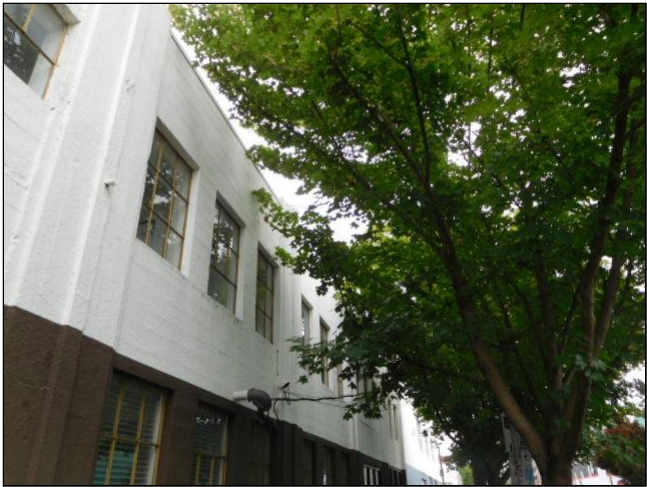
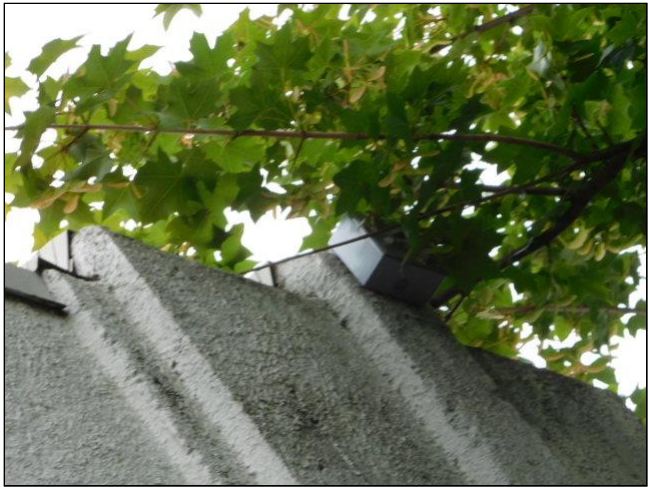
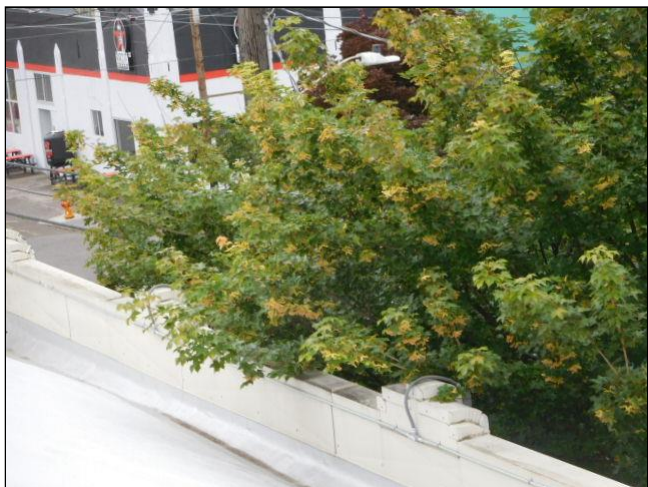
Trees overhanging the roof in contact with a roof and in contact with a building should be trimmed. Contact will accelerate deterioration.

Trees overhanging the roof in contact with a roof and in contact with a building should be trimmed. Contact will accelerate deterioration.  
\$650 - \$700

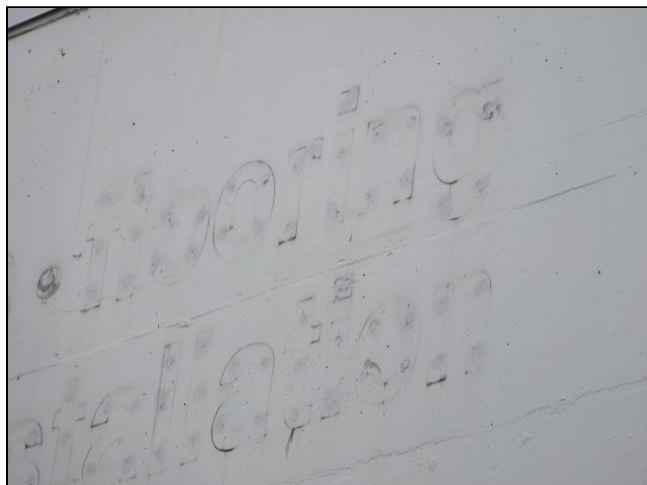
G. Item 1(Picture)

Removed signage at the rear of the building needs resurfacing or covering with new signs there is no real signage at the building front. This is a purely cosmetic issue.

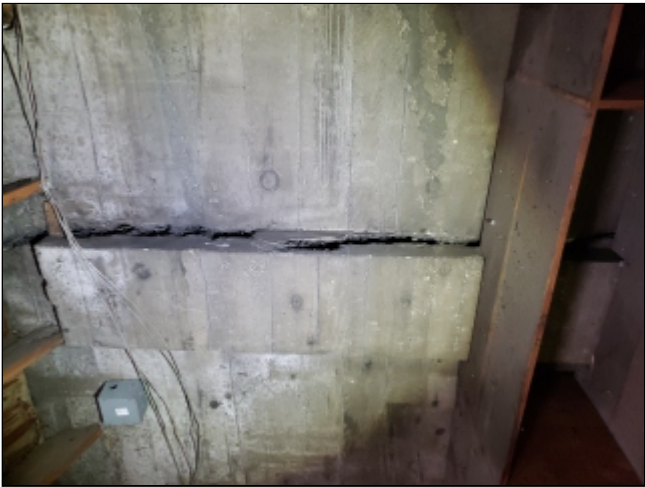
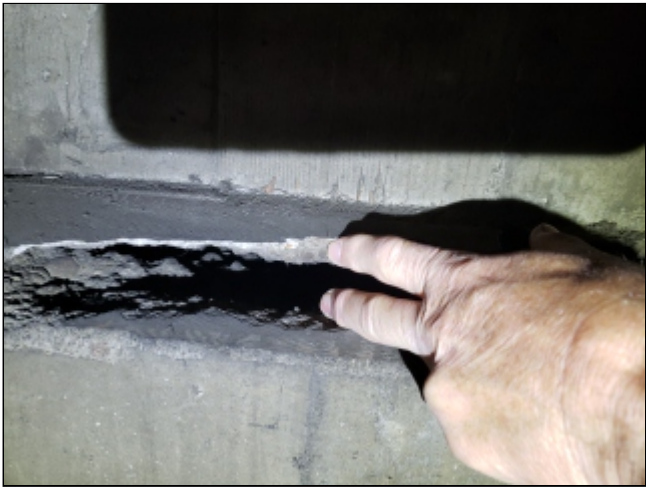
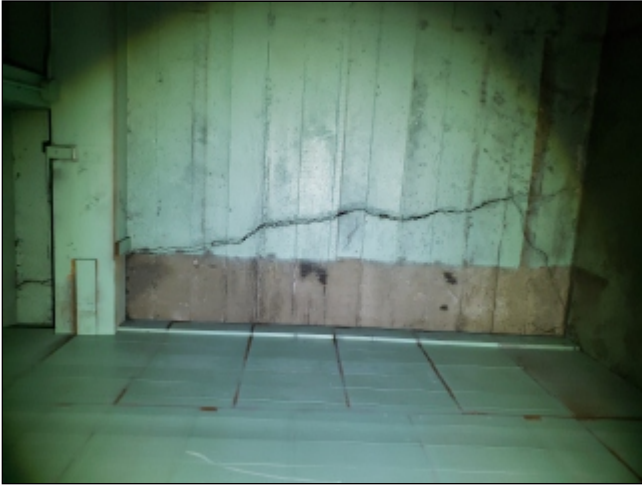
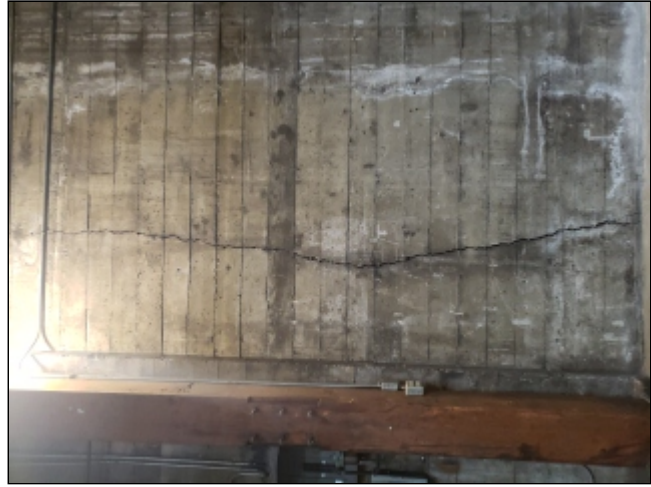
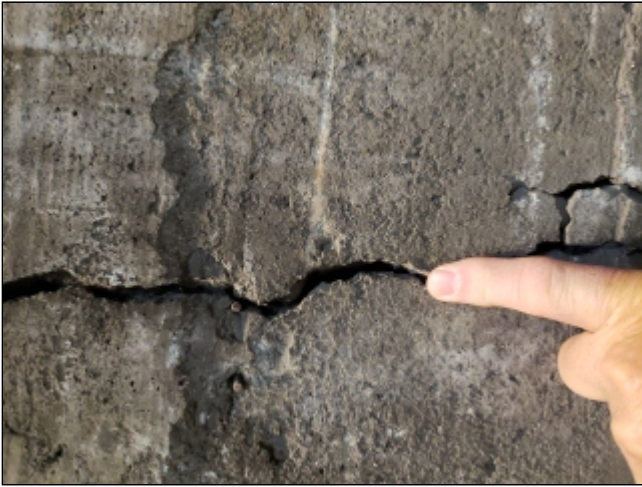
There is a substantial vertical separated suppling crack on the upper North wall. There are a few other cracks throughout, some vertical and some smaller horizontal. There is a pretty significant lower stair step crack. Vertical cracks historically are not structurally as damaging as horizontal cracks may be. In our experience this is unlikely to be a significant Structural issue. However you may wish to have this evaluated by a structural engineer. There is also a typical vertical settling crack on the North side this is not separated and on likely to prove a significant structural issue. However, particularly considering the couple of significant separated cracks, we think it would be prudent for you to obtain the evaluation of a structural engineer.

There is a substantial vertical separated suppling crack on the upper North wall. There are a few other cracks throughout, some vertical and some smaller horizontal. There is a pretty significant lower stair step crack. Vertical cracks historically are not structurally as damaging as horizontal cracks may be. In our experience this is unlikely to be a significant Structural issue. However you may wish to have this evaluated by a structural engineer. There is also a typical vertical settling crack on the North side this is not separated and on likely to prove a significant structural issue. However, particularly considering the couple of significant separated cracks, we think it would be prudent for you to obtain the evaluation of a structural engineer.

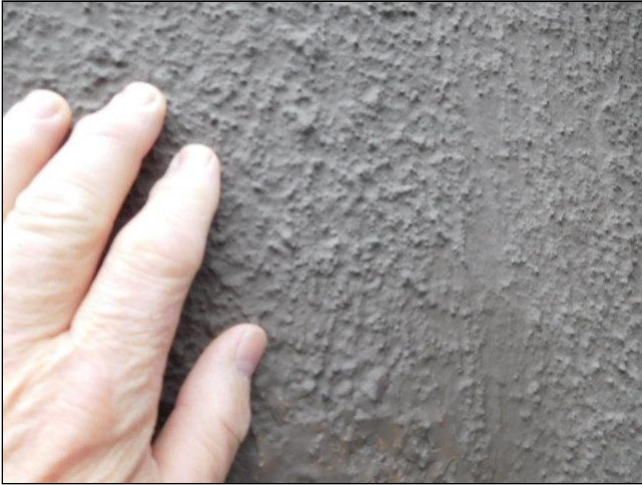
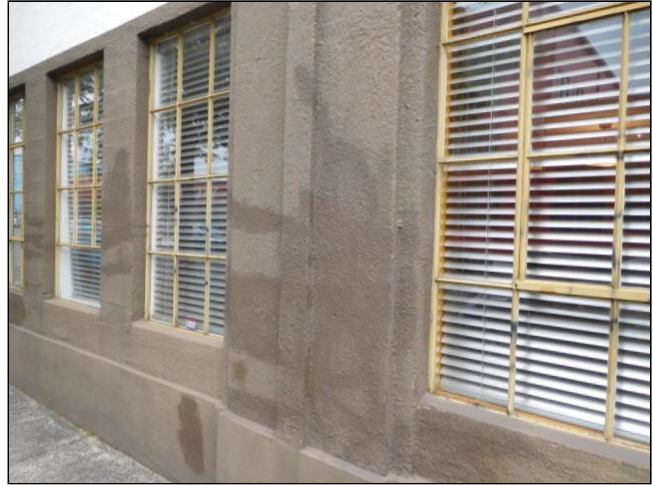
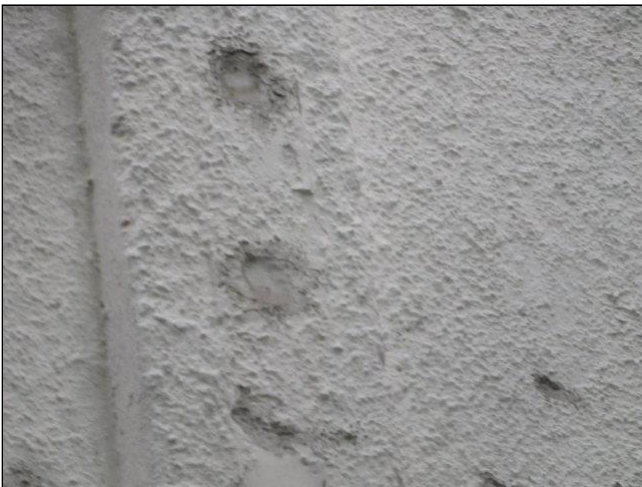
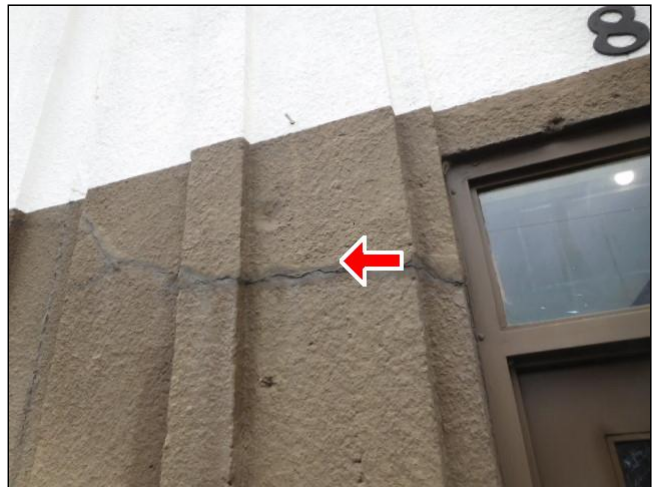
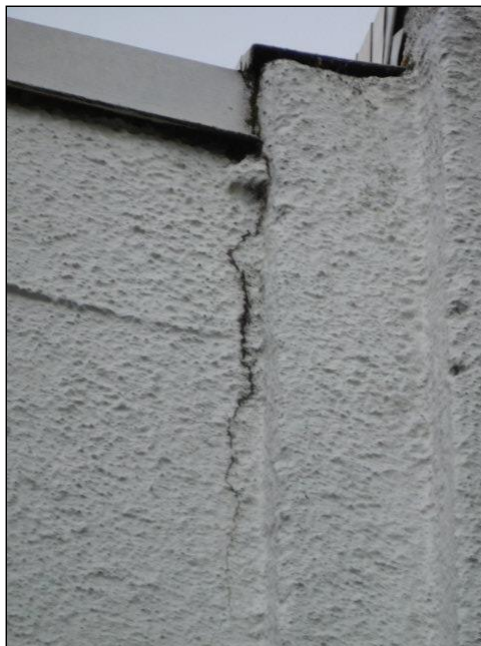
(1) There are a few typical settling cracks to the concrete building. Over all the masonry exterior is in good condition. The paint is beginning to oxidize and the building will need to be re painted.

(1) There are a few typical settling cracks to the concrete building. Over all the masonry exterior is in good condition. The paint is beginning to oxidize and the building will need to be re painted.

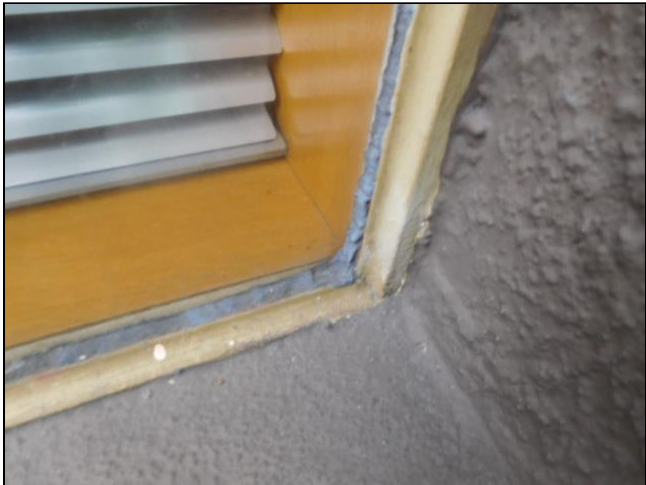
D. Item 1(Picture)

(1) All of the windows but one on ground level, are older metal sash single pane windows. These older windows will not operate as well as newer ones. Note; the older single pane metal sash windows are in better condition than average for their age and service. They do not require replacement at this time.

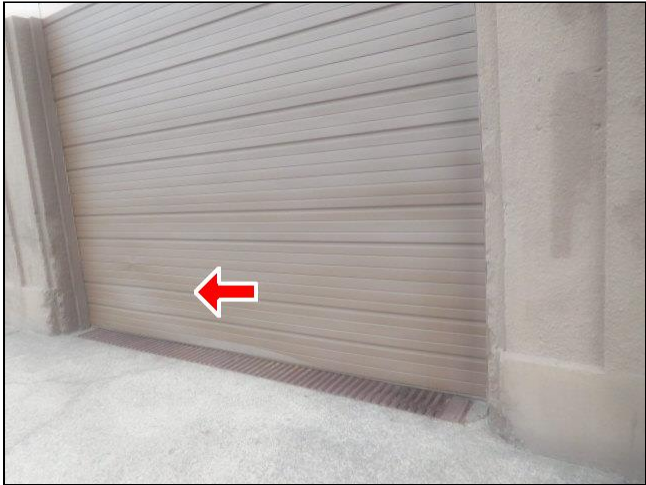
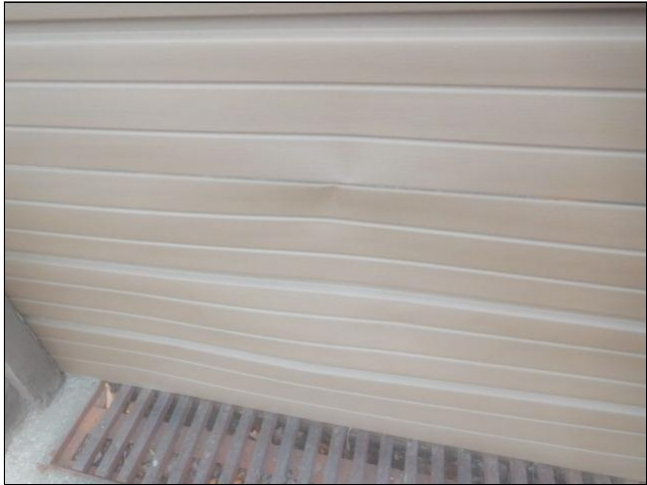
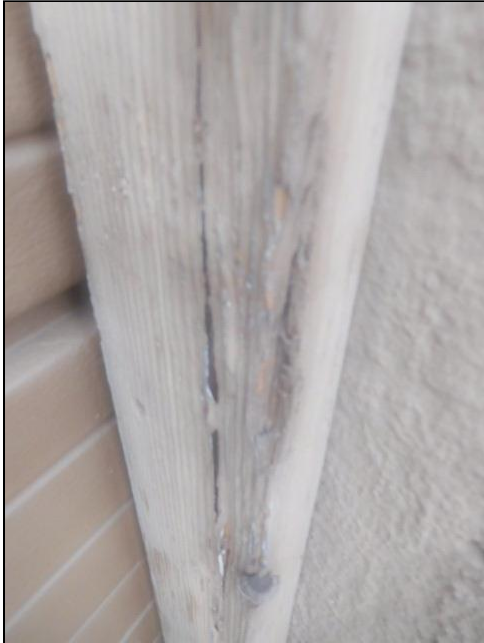
(2) There are two roll up mechanical doors, one is metal and has some typical minor mechanical damage. This damage does not interfere with its operation and there is no recommended service at this time. There is some wood trim on the exterior of this roll up door that is dry rot damaged and needs replacement. The older automatic operator for the metal rollup door is not operational and not connected. This door can only be operated manually. The newer metal and glass roll up door is only manual operation. The newer glass roll up door is in excellent condition.

(2) There are two roll up mechanical doors, one is metal and has some typical minor mechanical damage. This damage does not interfere with its operation and there is no recommended service at this time. There is some wood trim on the exterior of this roll up door that is dry rot damaged and needs replacement. The older automatic operator for the metal rollup door is not operational and not connected. This door can only be operated manually. The newer metal and glass roll up door is only manual operation. The newer glass roll up door is in excellent condition.

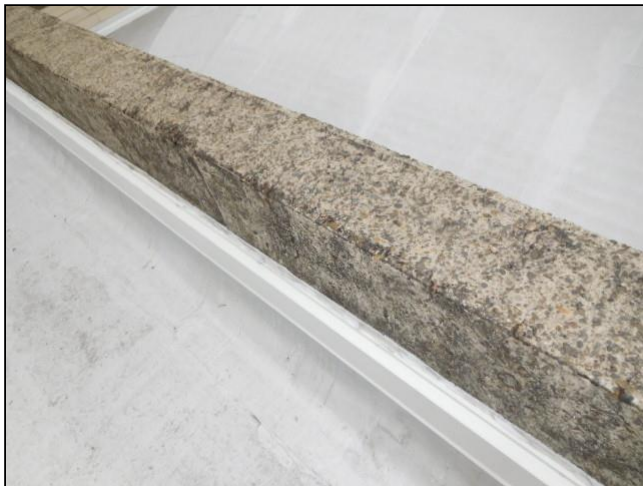
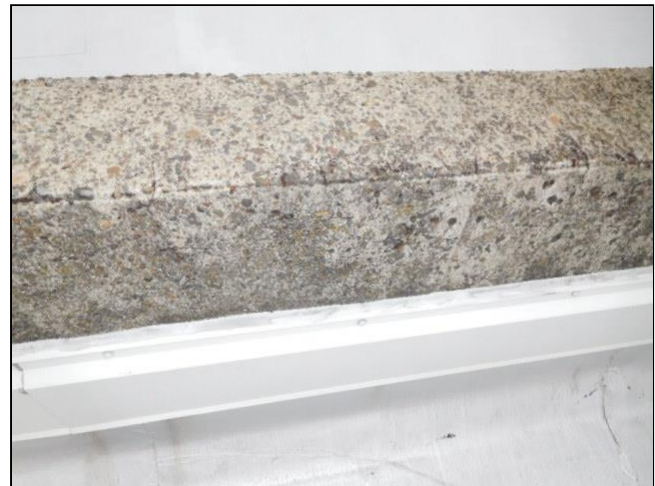
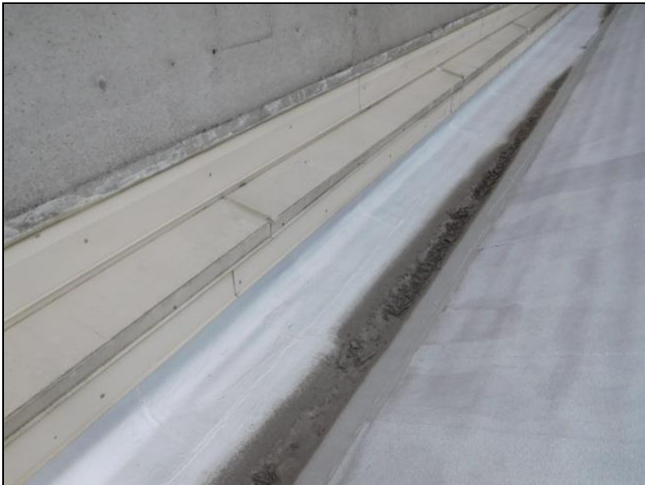
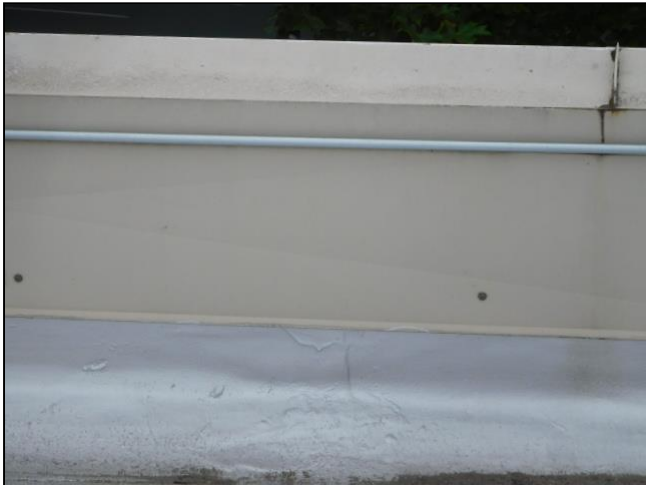
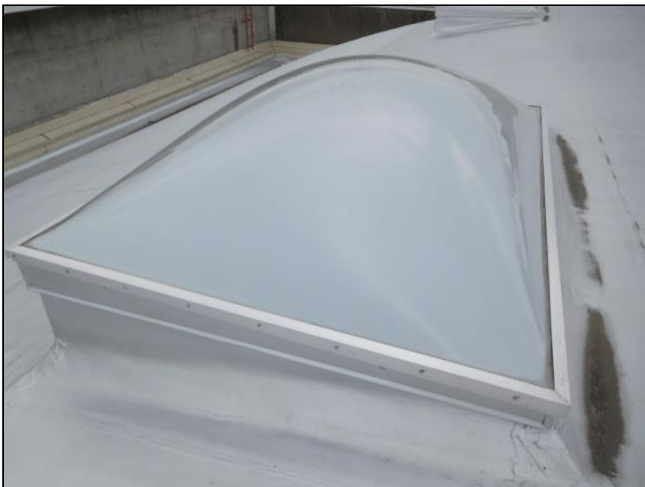
Good seal & sheet metal flashing.

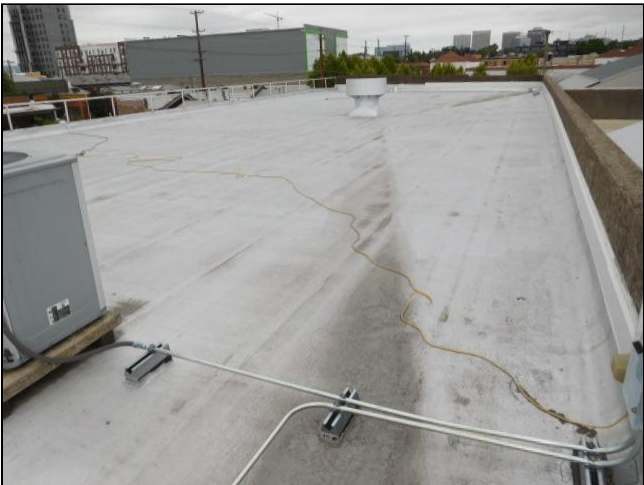
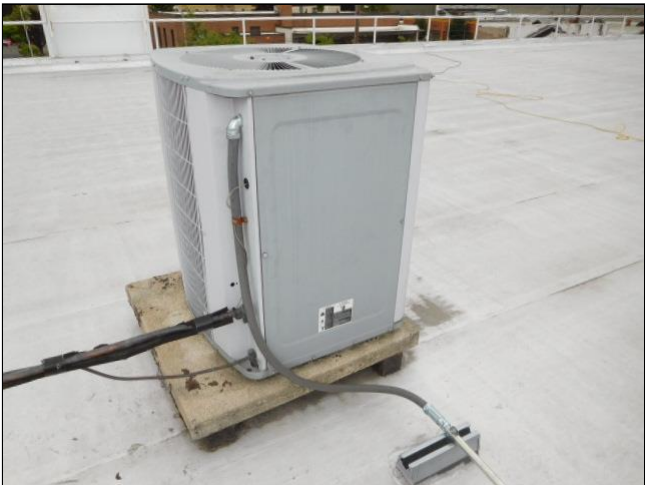
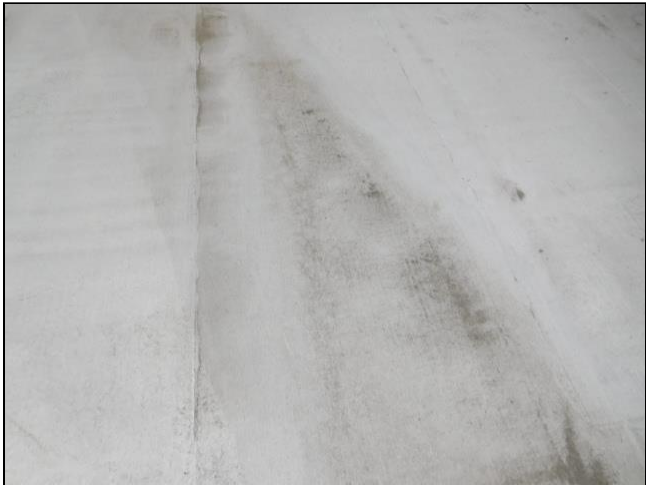
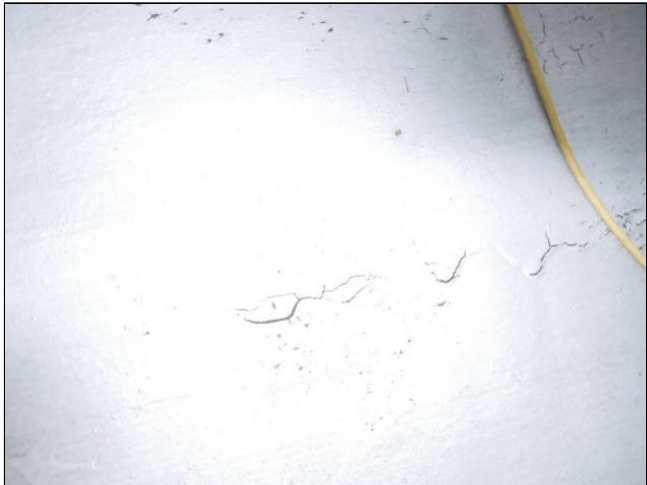
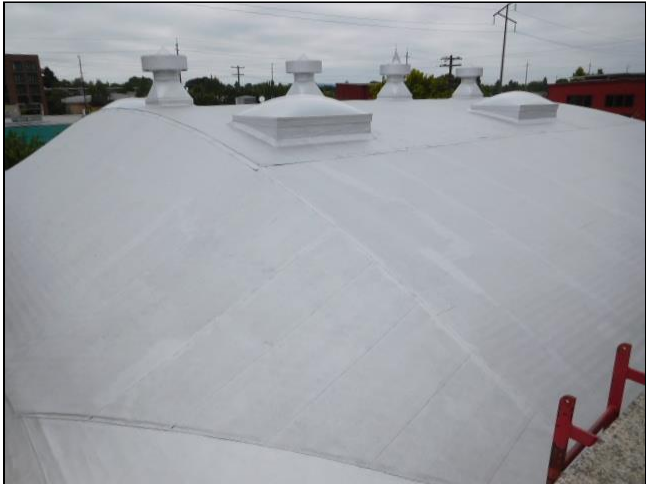
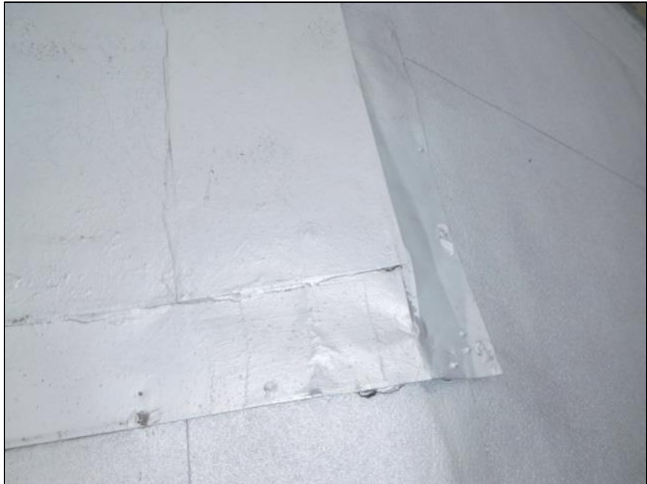
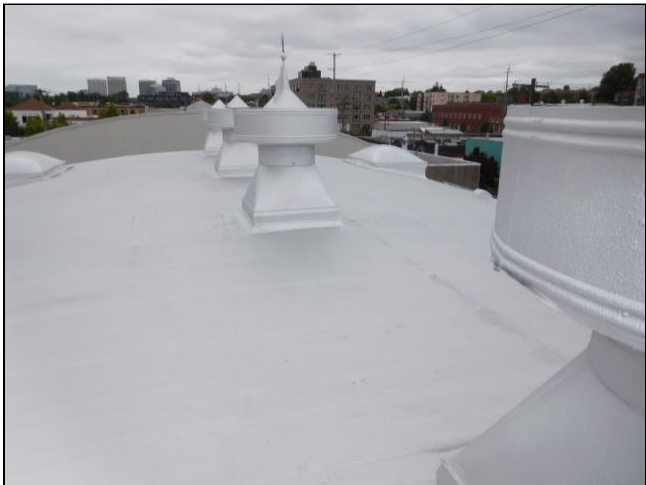
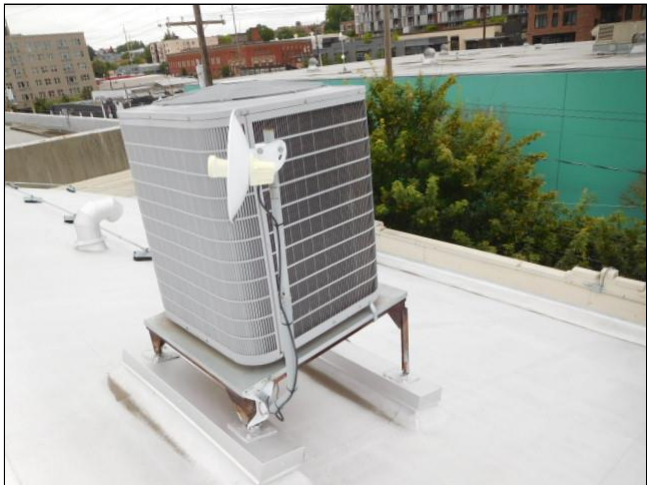
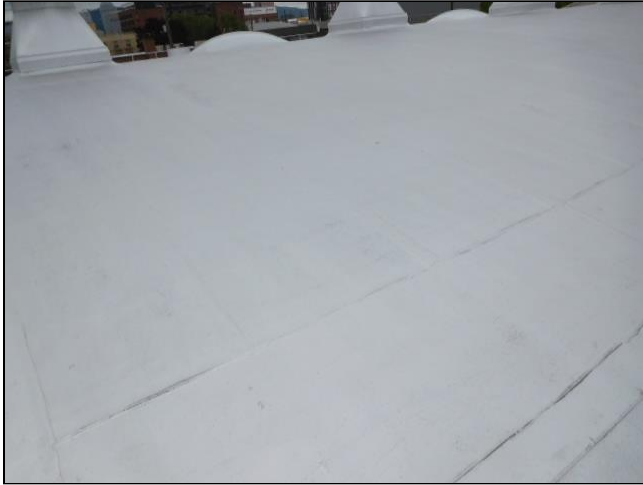
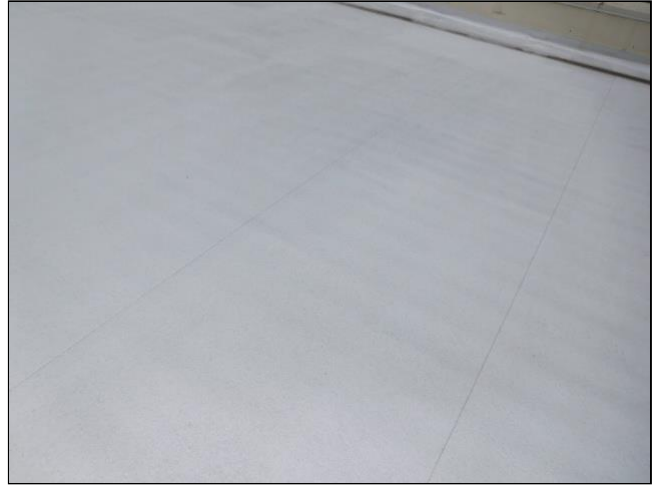
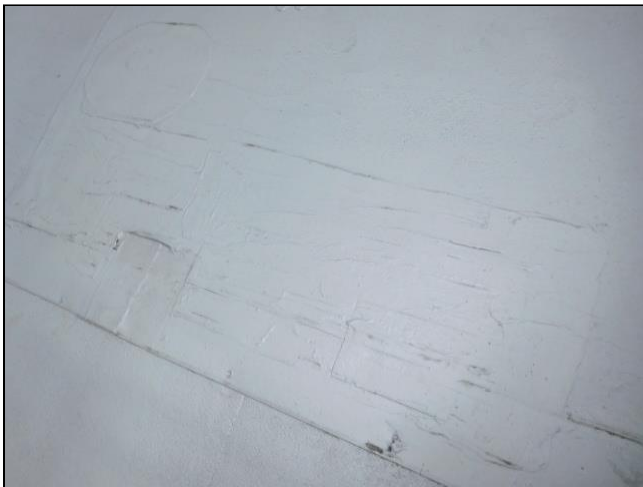
Overall the roofing is in all pretty good condition. It has been replaced in sections over time. Everything here should last 5 or more years with regular maintenance. The oldest section is the topmost part of the barrel or round roof section. That area consists of about 4,000 SF. It will need replacement 1st, probably around the 5 year mark. That section should cost about \$20,000 to replace. The lower part of the barrel roof is relatively new and the flat section is good.

Overall the roofing is in all pretty good condition. It has been replaced in sections over time. Everything here should last 5 or more years with regular maintenance. The oldest section is the topmost part of the barrel or round roof section. That area consists of about 4,000 SF. It will need replacement 1st, probably around the 5 year mark. That section should cost about \$20,000 to replace. The lower part of the barrel roof is relatively new and the flat section is good.

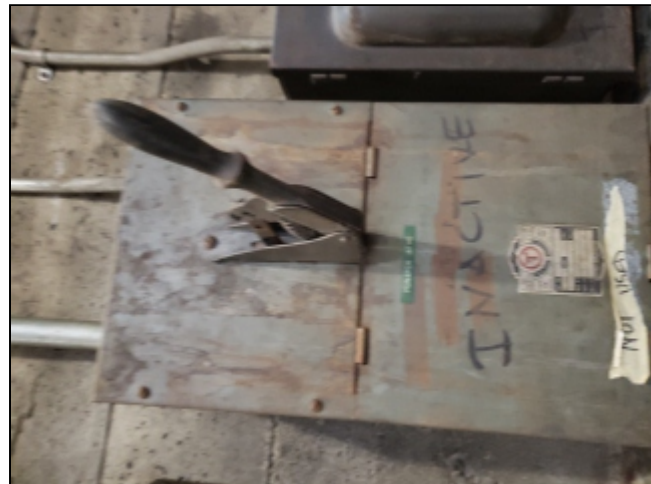
G. Item 2(Picture)

(1) Very old MCC switch station service most of which is out of service. Recommend removal and proper decommissioning.

(1) Very old MCC switch station service most of which is out of service. Recommend removal and proper decommissioning.  
\$1,800 - \$2,500

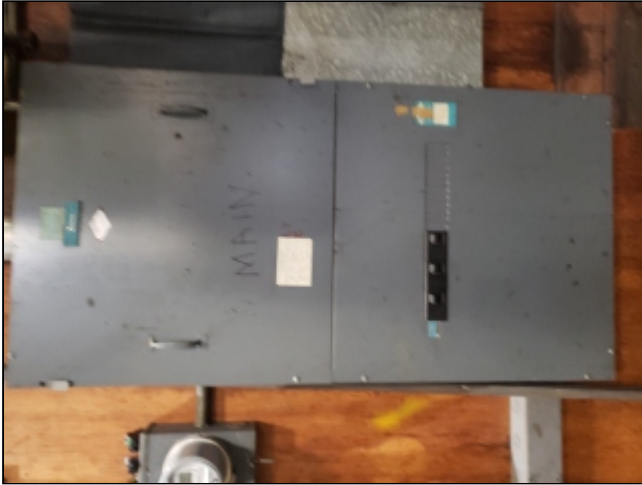
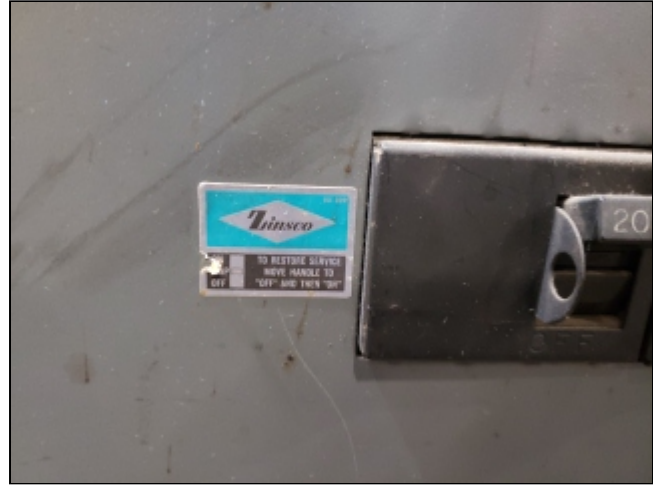
(2) Old zinsco main 600 amp service disconnect panel.

You have a Zinsco panel which is legal, but there is a possibility that the circuit breakers may not trip when shorted possibly causing an electrical hazard. Opinions by licensed electricians on this panel varies between safe and unsafe. There is considerable information available on the internet regarding these panels, most of it bad. I recommend you consult a licensed electrician for an opinion and consider the cost of replacement.

In our experience these larger industrial sized units are more reliable. It also may not require replacement of the panel itself, only the 3 disconnect breakers. This unit may also be eliminated by the installation of new sub panels.

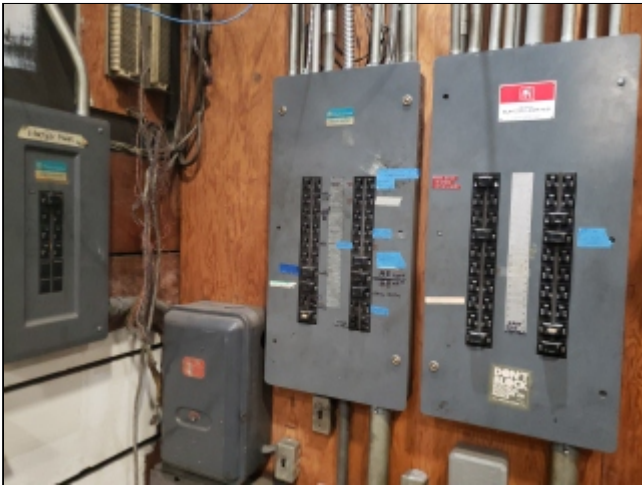
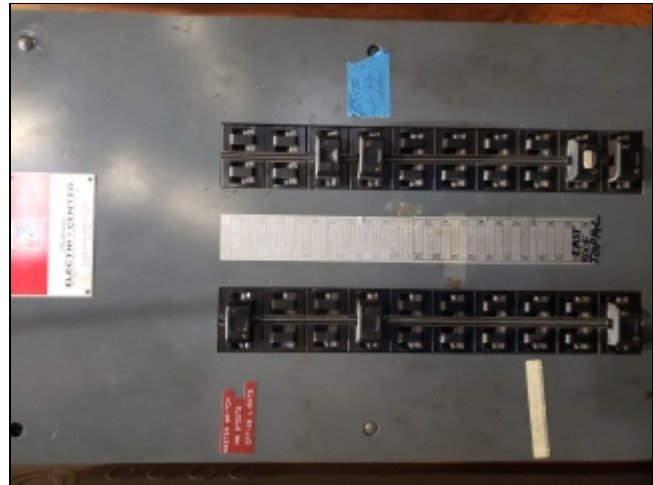
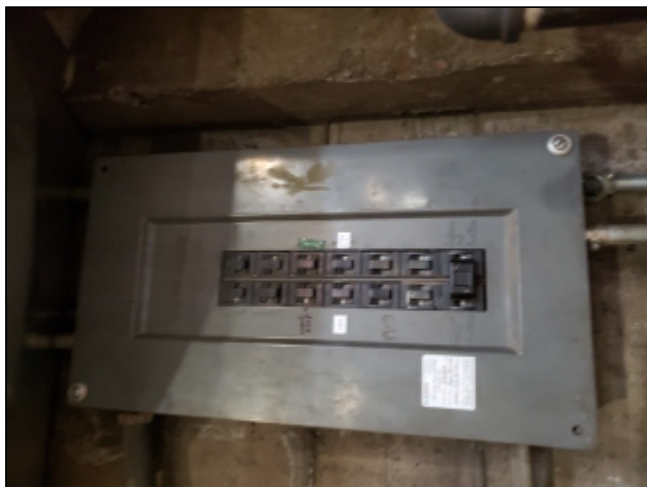
(3) Old ITE bulldog push matic electrical panels. 3 panels in the older industrial section and 2 small sub panels in the office area.

State of breaker On-Off unclear: Push-Matic breakers have an indicator flag showing whether the circuit is on or off. Many times, on old Push-Matic breakers, this on/off flag will stay fixed in either position, giving you a false indication of the condition of the circuit.

Most commercial electric service professionals will recommend replacement of these units along with updating the antiquated wiring usually associated with them.

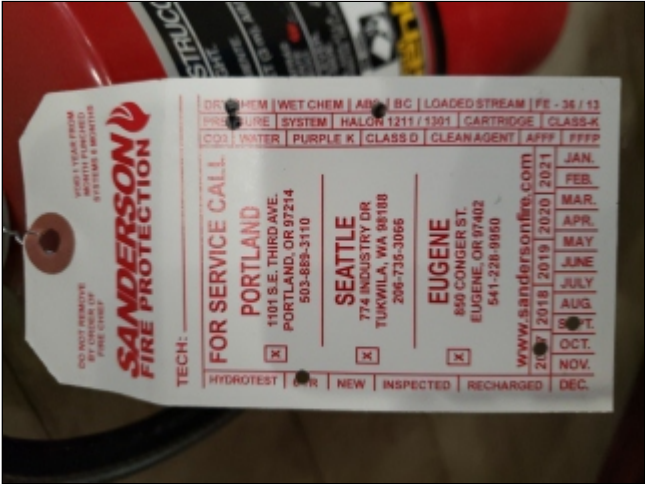
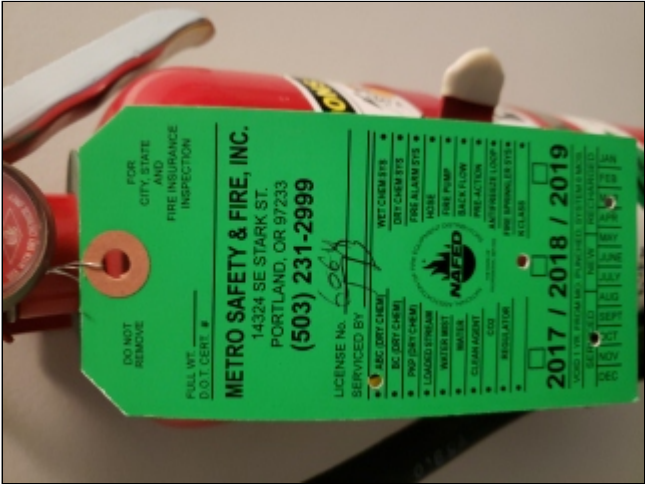
Fire extinguishers are out of date for annual testing and certification.

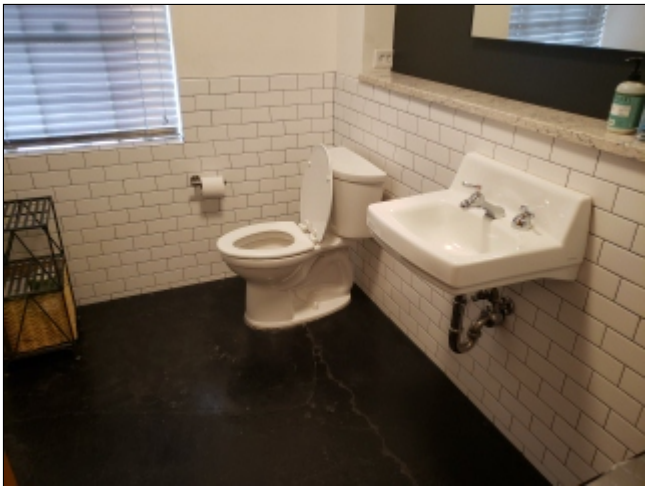
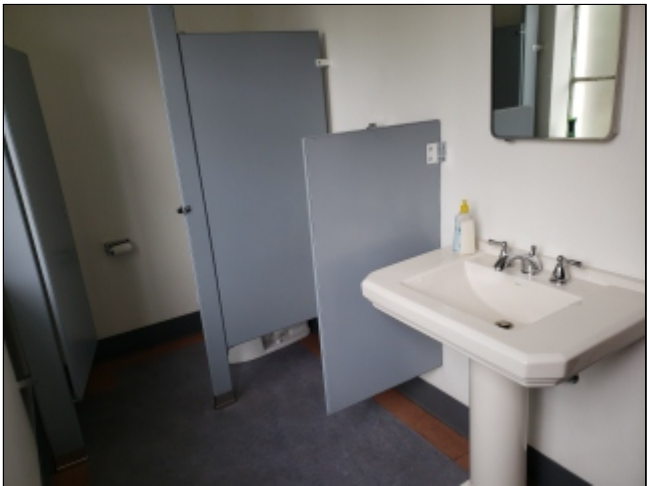
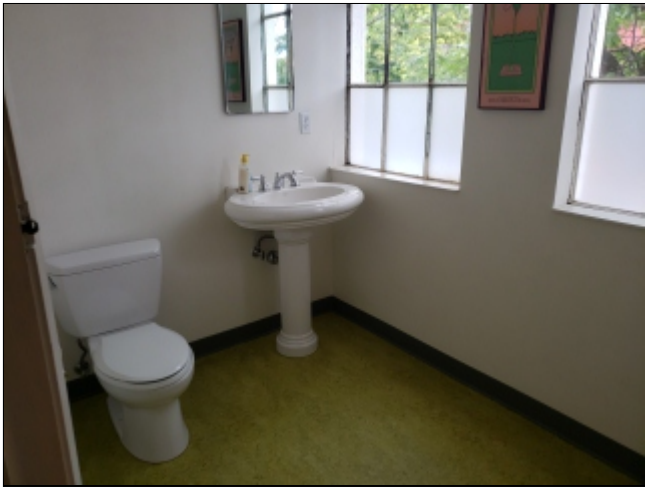
Bathroom acceptable but not set out for ADA compliance. 2nd floor bathrooms acceptable, not set up for ADA compliance. Note, 2nd floor not accessible.

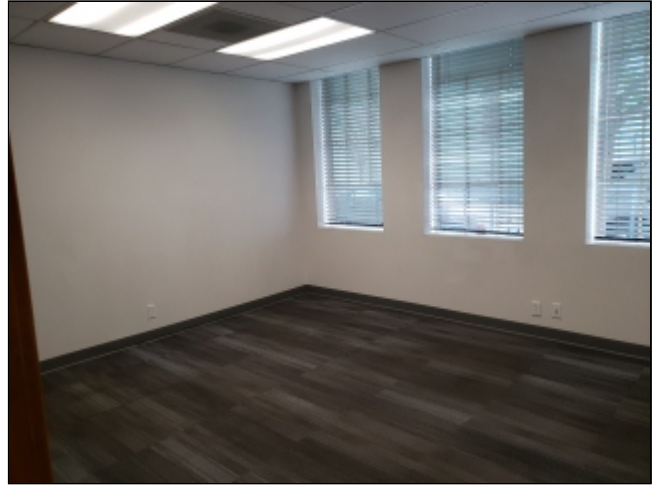
F.1. Item 2(Picture)

A few offices were locked and and occupied and therefore not accessible. All accessible office spaces were in acceptable condition.

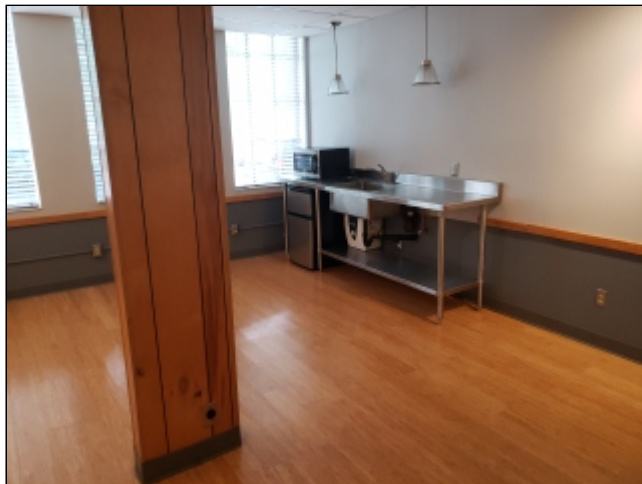
J.1. Item 1(Picture)

Pretty basic just a sink counter refrigerator and microwave no other build in appliances. Room is fully decorated and the and good condition.

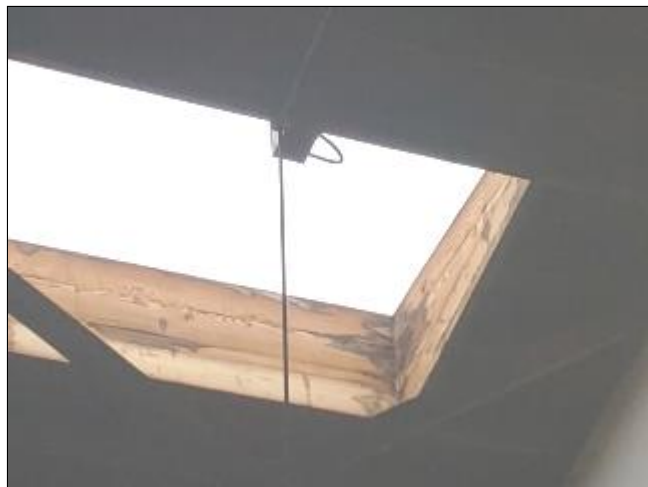
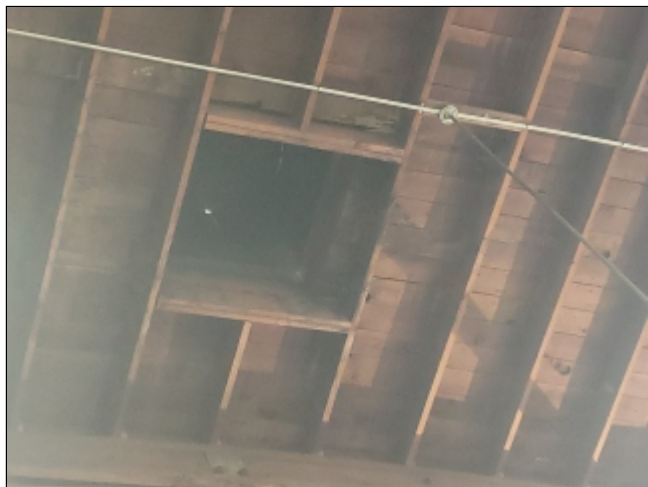
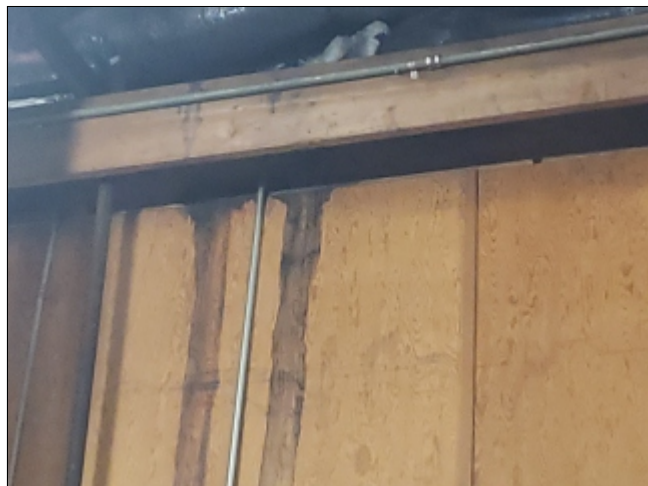
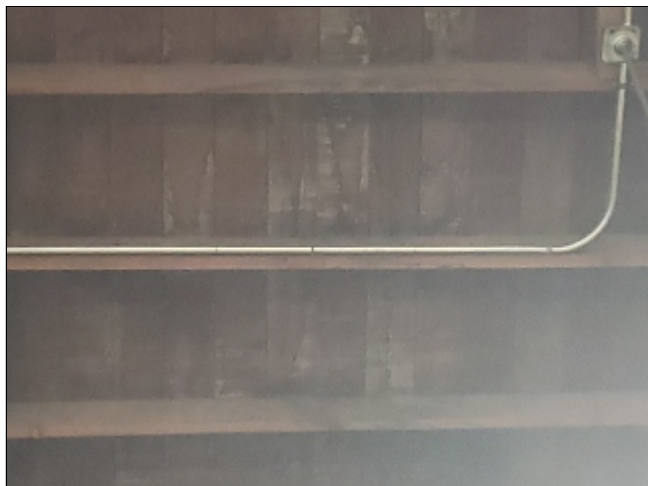
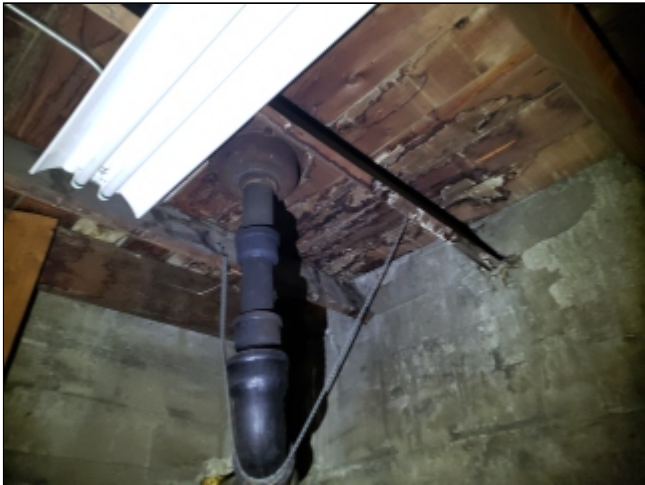
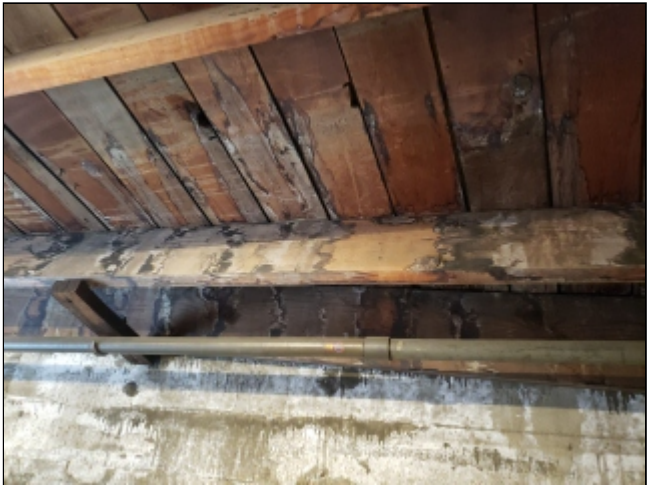
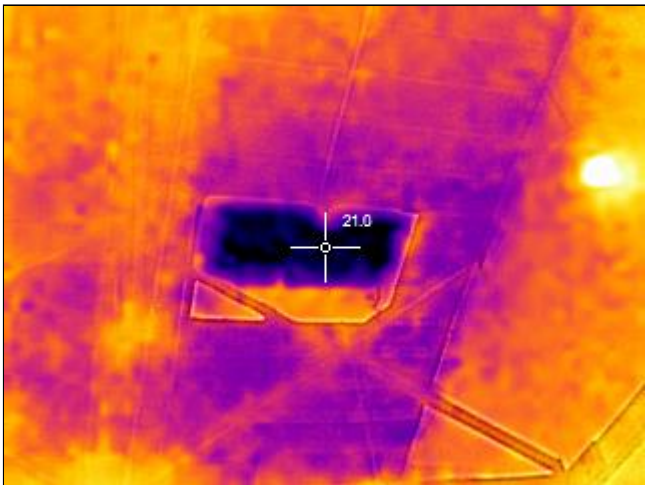
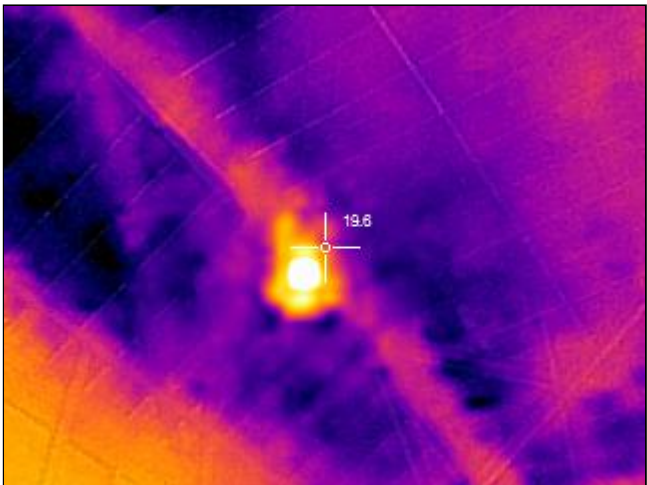
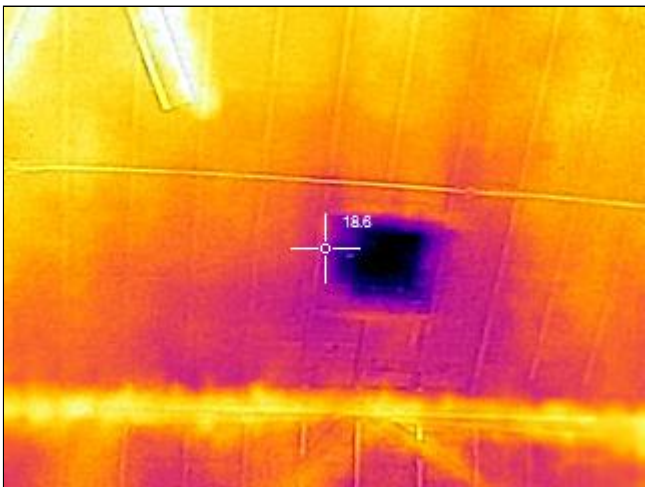
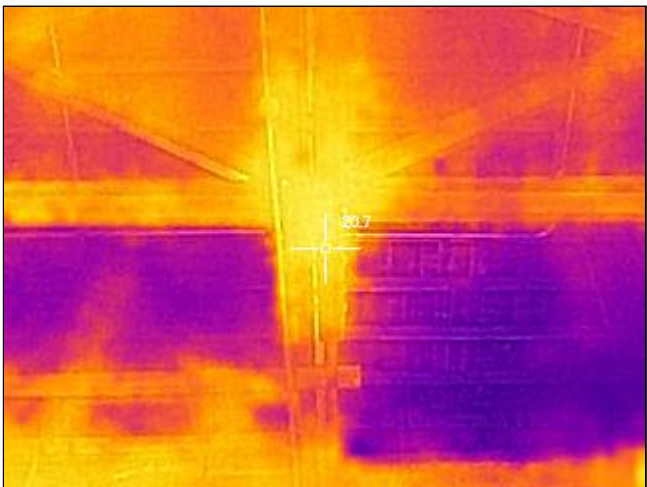
Interior ceiling framing and walls show evidence of moisture intrusion. All of this tests dry at time of inspection by infrared analysis's. These issues pre date existing roof surface.

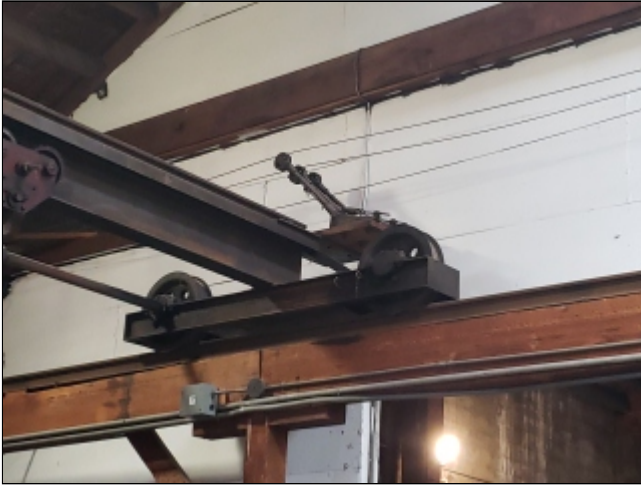
B.2. Item 1(Picture)

There is a very old overhead Crane structure and mechanism that is well out of date and would require substantial updating in order to make useful and safe.

There is an older overhead Crane mechanism that is not functional at the time of inspection but all the components are here and this unit could be put back into service. Full evaluation of necessary repairs would have to be conducted by a specialist repair company.

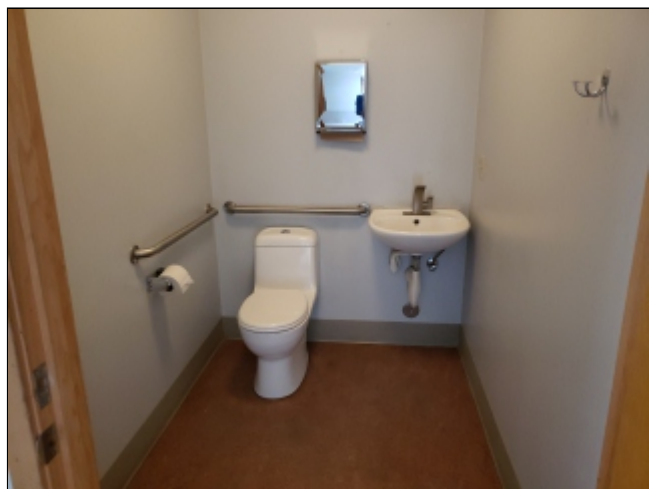
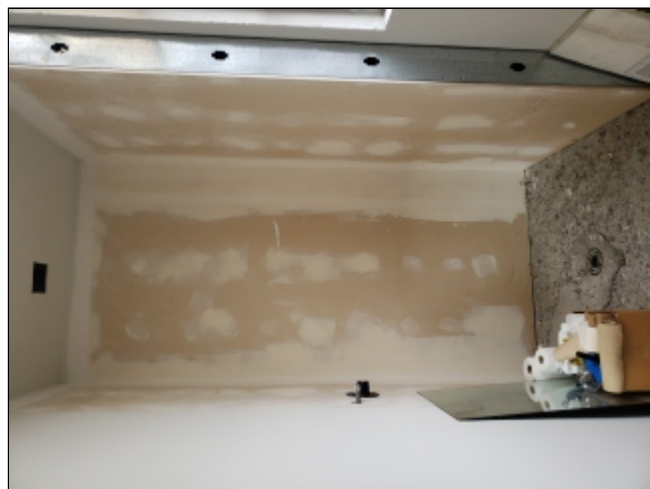
2 bathrooms both are Ada compliant. There is an unfinished shower area off the existing bathrooms.
