# Inspection Report

Property Address:

Portland OR

### Executive Summary

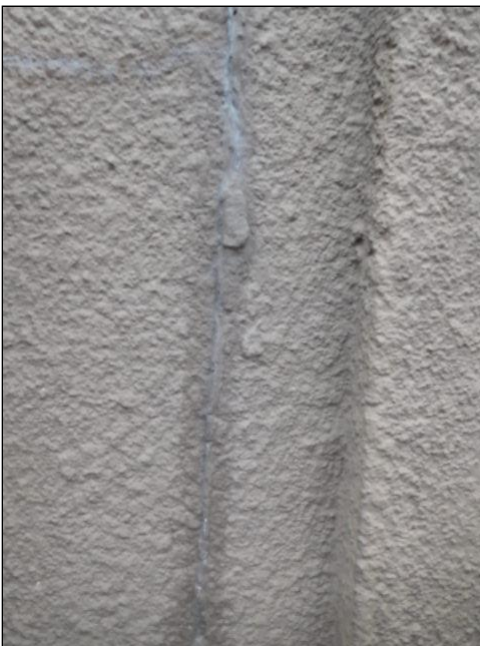
C. Item 5(Picture)

There is a substantial vertical separated suppling crack on the upper North wall. There are a few other cracks throughout, some vertical and some smaller horizontal. There is a pretty significant lower stair step crack. Vertical cracks historically are not structurally as damaging as horizontal cracks may be. In our experience this is unlikely to be a significant Structural issue. However you may wish to have this evaluated by a structural engineer. There is also a typical vertical settling crack on the North side this is not separated and on likely to prove a significant structural issue. However, particularly considering the couple of significant separated cracks, we think it would be prudent for you to obtain the evaluation of a structural engineer.

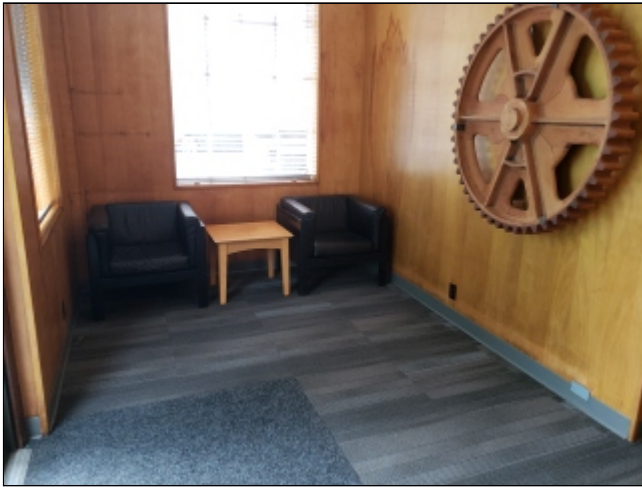
D.1. Item 1(Picture)

Acceptable.

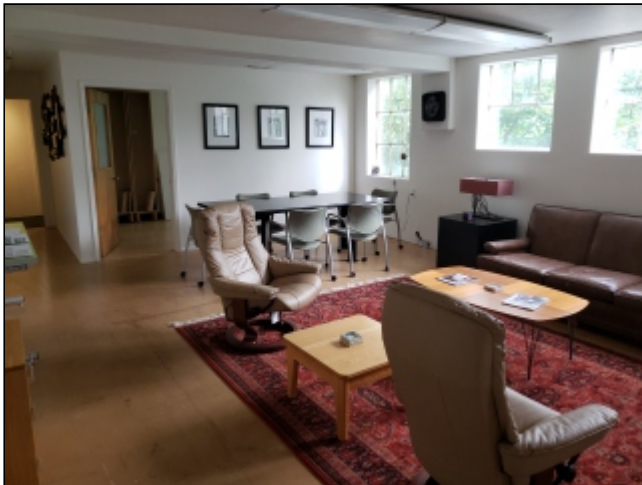
E.1. Item 1(Picture)

Acceptable
